DEPARTMENT OF DEFENCE DEFENCE SCIENCE AND TECHNOLOGY ORGANISATION AERONAUTICAL RESEARCH LABORATORY

Aircraft Systems Project Document 003

FATIGUE TESTING OF THE MK3 MODO 2000 LB BAIL LUGS: TEST REPORT

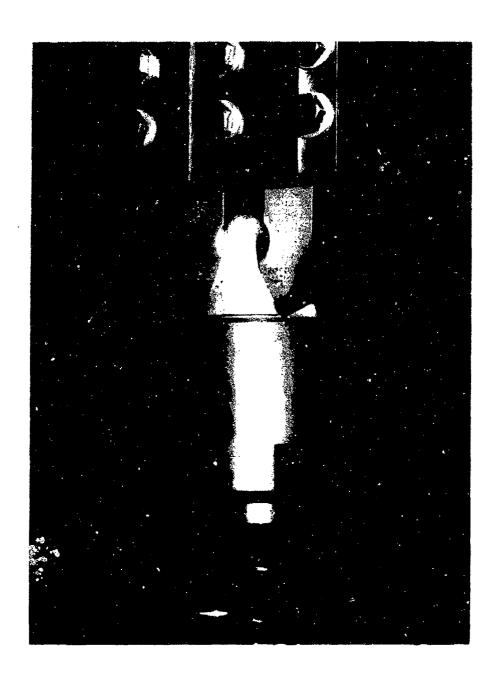
FIGURE 4: LUG FAILURE MODES

The items tested appear to exhibit several different failure modes, however, on closer examination it is noticed that for most of the lugs, the crack growth initiates horizontally at the base of the inside corner radius where it joins the vertical leg. After this initial cracking the failure either continues horizontally, at 45° across the corners, vertically up, or some combination of these. There were some lugs however, which broke in the centre of the bail, and these have been identified in the tables of results. Examples of these failures can be seen in Figure 4.

The lugs which failed in the centre of the bail also exhibited crack growth in the vertical legs. The sequence in which these cracks occurred is not known, however, it was thought most likely that the lug broke at the centre first, followed by the failures in the side legs. If the failures had initiated at the vertical legs there appears to be no reason for the occurrence of the central failure.

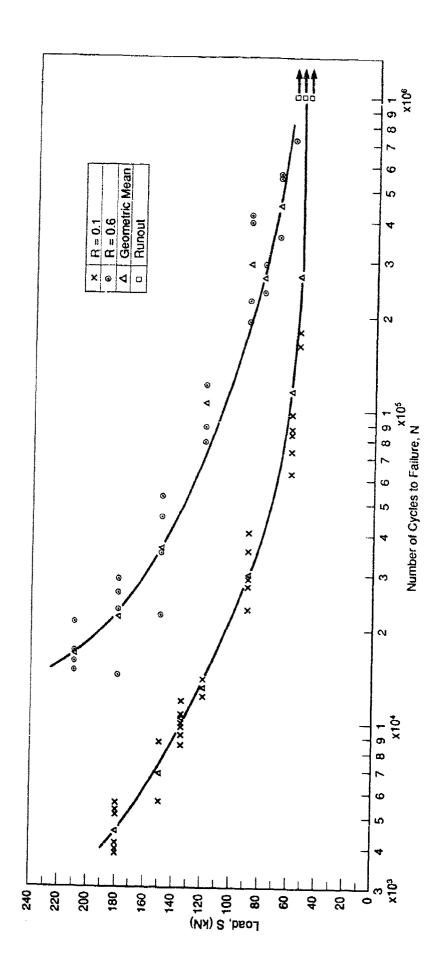
FIGURE 5: MAXIMUM LOAD VS NUMBER OF CYCLES TO FAILURE

A summary of the test results can be seen in Table 1 and Table 2. These tables contain the results from the preliminary testing as well as those from the replicate testing at the selected maximum loads. At the lower end of the load spectrum there are results which have been obtained whilst trying to locate the load resulting in run-out. These results are presented graphically in Figure 5. The lug identification in these tables refers to lugs from four different lot numbers as follows:
